Influence of Vibration and Ground Deformation on Historic Structures: Case Study

Zdeněk KALÁB^{1,2*}, Roman ŚCIGAŁA³ and Piotr STRZAŁKOWSKI⁴

Abstract

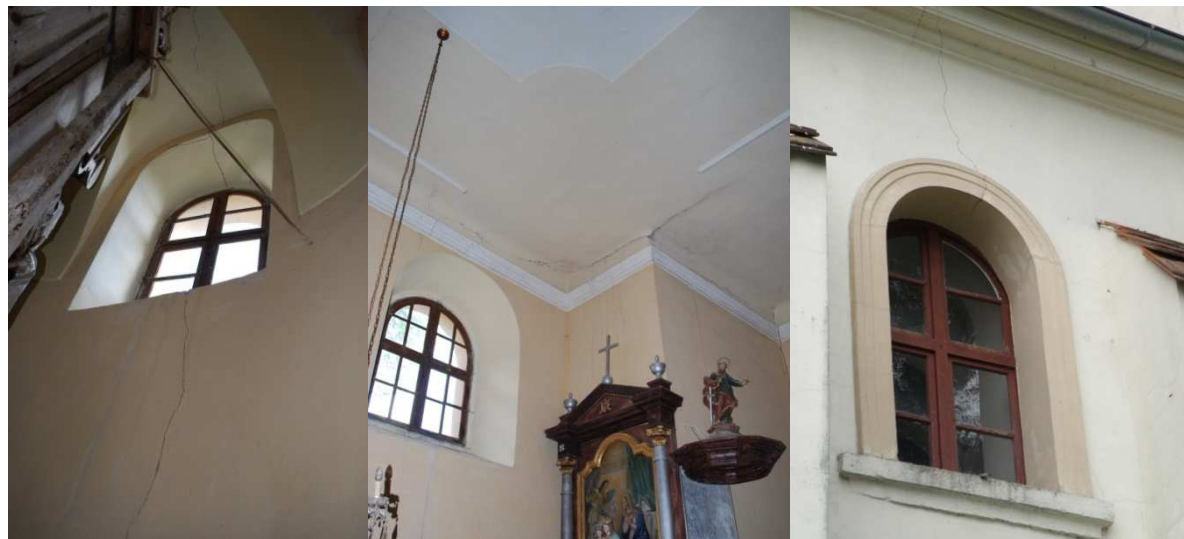
From a geological point of view, the area is characterized by very thick Quaternary sediments. The main cause of failures is probably the instability of soils under the basement, partly in a slow slope. Vibrations generated by traffic, especially by agricultural vehicles and trucks, increase the loading of this historic church. The minimum distance between the sensor and the road was 14 m. (see Fig. 3). To evaluate seismic loading, seismic measurements were performed in 2010. The measuring points were located not only in the church (ground floor and higher places under the roof) but also on the profiles leading from the church to the road. Seismic apparatuses GAIA and seismometers Le3D type were used (frequency range of seismic channels is 0.5 – 100 Hz, dynamic range is more than 130 dB).

Experimental measurements have shown that the primary cause of damage to the church in Světí is the foundation of the building in a sloping area. The vibrations generated by traffic on nearby roads do not reach values that would directly cause damage to the building. Thanks to the historical value of the building, we can reduce the values of maximum permissible vibrations. It can be reasonably assumed that the vibrations significantly worsen the technical condition of the building.

Fig. 2B Fractures of the walls and on the ceiling in the St. Andrew church; photo: Lednická

The first case study represents seismic loading of the surface structure – the church in Světí. Extensive damage can be observed in the church, especially the fractured masonry and the ceiling. The maximum measured vibration effect reached the value of $0.44 \text{ mm}\cdot\text{s}^{-1}$, so it is low according to the Czech technical standard and does not cause damage to the evaluated structure. Experimental seismological and seismic measurements have shown that the most important factor is probably the instability of soils under the basement, partly in slow slope. Nevertheless, the influence of heavy traffic on the nearby road, which causes vibrations in the structure, cannot be neglected. As mentioned, these vibrations are not the primary cause of these damages, but they significantly contribute to the opening of existing fractures and, thus, to the gradual deterioration of the technical condition of the church.

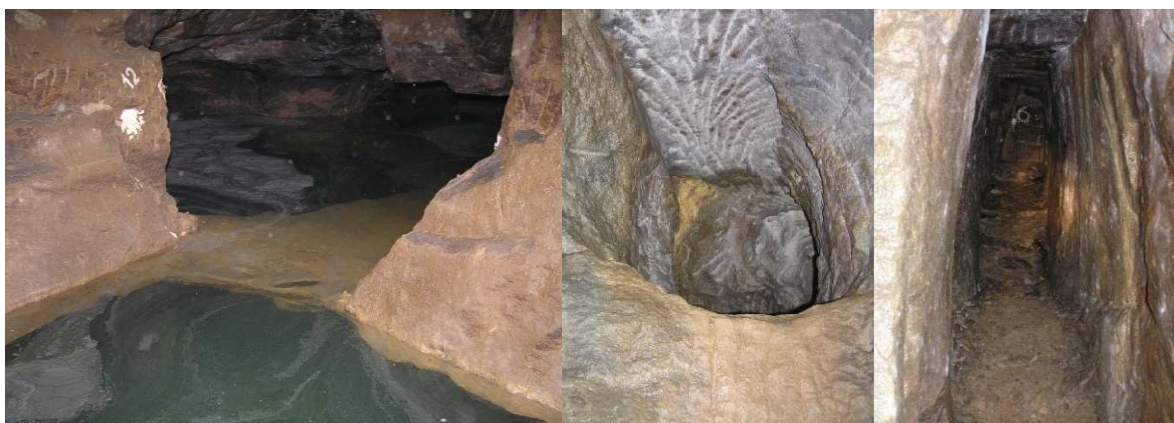
The closest focal area of natural earthquakes to the monitored area of the Jeroným Mine in Čistá is located approximately 25 km to the west (for instance, Fischer et al., 2010, 2014). Young tectonic movements accompanied by volcanic activity influenced the geological pattern of this region as early as during the Tertiary. Even today, weaker earthquakes are detected in West Bohemia and Vogtland (Germany), the strongest of which are felt by people who live here, or they can damage buildings. This area is characterized by seismic swarms lasting several days up to a few months. Critical places from the viewpoint of vibration effect are fissured and weathered supporting pillars, hanging layers on the roof in chambers, and caving falls of rock leading into the chambers due to collapsed overburden.

Fig. 6 Photos taken in the historical parts of the mine (fire setting, extraction using a picker and miner's hammer, underhand stopping or overhand stopping); photo: Lednická

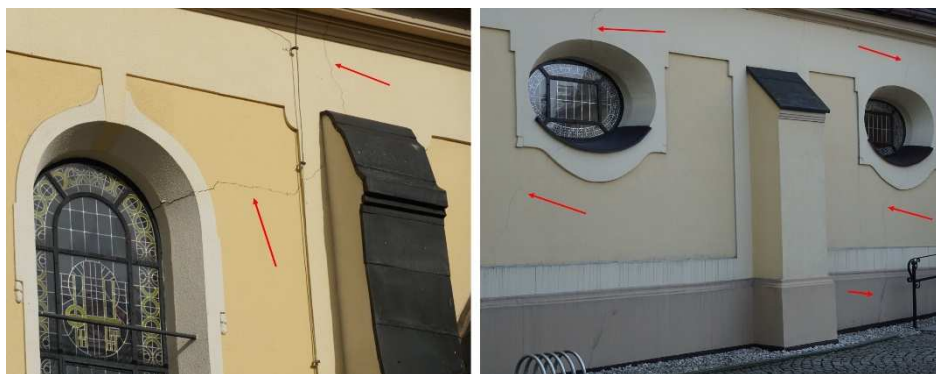
Fig.11 Fractures on the walls of the church; photo: Šcigala

As can be seen from the table, according to the GSIS-2017 scale, mining-induced vibrations at the church location did not affect the building in a way that would cause new damages or intensify the existing ones.

A separate issue is whether the combined effect of continuous deformations (subsidence, tilt and horizontal strain) together with mining-induced vibrations could generate new damage. The answer to this question is not easy and requires detailed research for each case. In general, it can be concluded that the impact on the church of underground mining extraction was not intense enough to cause significant damages, although some damages occurred, as shown in Fig 11.

An example presented by the Polish Church of the Body of God shows that one should be aware that even when results coming from separate analyses of two different impacts of underground mining do not show the potential threat to the object, aggregate influence may be the cause of damages to structures. In the presented case, the assessed PGA and PGV values (according to Polish regulations) point out that no damages should occur due to mining-induced vibrations. Moreover, measured and calculated deformation indices in the area surrounding this object should not significantly impact the object. Finally, it is very important to keep in mind the possible scenario of combined influences, which acting together may pose a significant threat to the object's construction.

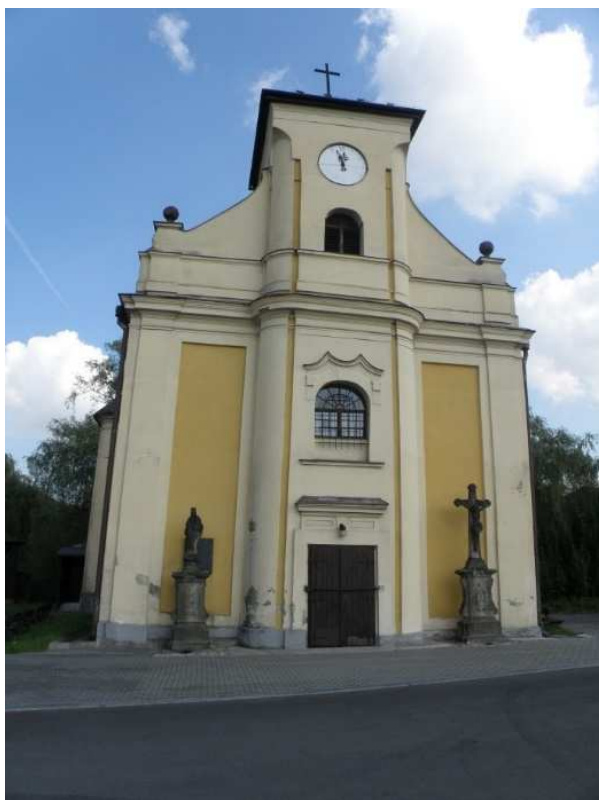
Due to the negative effects of coal mining in this area, the original high tower was demolished. The ground where this church stands subsidence by 37 meters (the mining started in 1891, with mining depth up to 682 m) in just a few decades due to the collapse of mine spaces under the site (Tab. 2); the sinking caused deep and wide cracks in the walls. Now the church is leaning 6.8 degrees to the south (in 1968, it was 7.8 degrees) – but it is still standing, and it has become a unique and renowned tourist attraction. It leans almost as much as the world-famous Leaning Tower of Pisa, and its history is just as fascinating in its own way. Visitors can enjoy the strange sensation of standing on level ground while the building next to them seems to be falling down. The church is listed in the Czech Book of Records and Curiosities.

Fig.11 Church of St. Peter of Alcantara, the town of Karviná, Silesia, Czech Republic (sinking by 37 meters, leaning 6.8 degrees to the south); photo: Kaláb

The last topic covers the impact of underground mining on surface objects. The leaning of the Church of St. Peter of Alcantara in Karvina documents its sinking of about 37 meters due to underground exploitation. The current effect of this situation is deep and wide cracks in the walls; the church is inclined 6.8 degrees. General reconstruction of the church (including fortification of walls and ceiling) and arrangement of the surroundings caused the structure is registered as a historical monument.

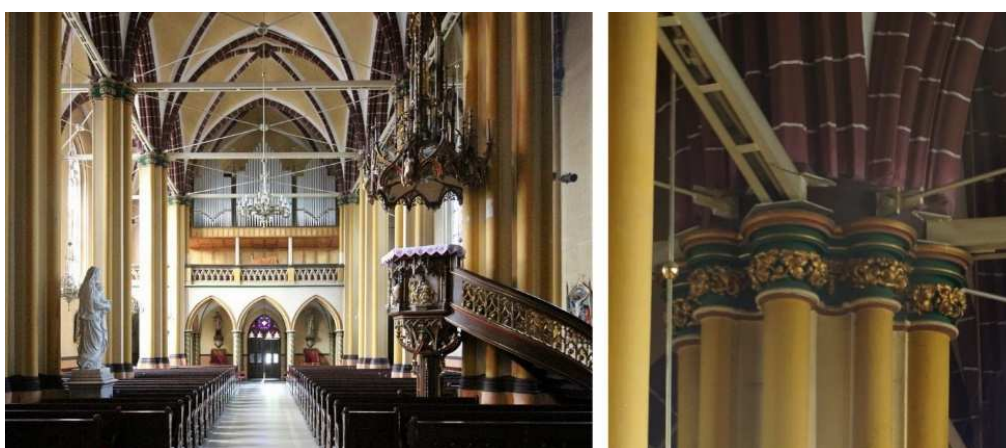
Despite the applied protections, the church building underwent further damage after the year 2000. For this reason, in 2006, an additional stiffening was made horizontally at the base of the vaults. In order to absorb the compressive stresses along the ties, complementary struts were installed. Further elements of C sections (covering

Fig.13 Some elements of inner reinforcement of the church construction; photo: Šcigata

The church building was not protected against mining damage during its construction. The protection of the structure, described below, was carried out successively from 1956. Originally, at the height of 10.0 m, steel ties made of Ø30 rods were installed in the church building, running in the longitudinal and transverse directions of the building along the line of all the pillars. The tie rods were anchored outside the walls with 250mm x 250mm x 15mm retaining plates. The tie rods were joined outside the pillar with turnbuckles enabling adjustment. At that time, two reinforced concrete struts were also made in the side transepts at the height of 5.0 m. Additionally, beams made of steel I-sections were built under the gallery.

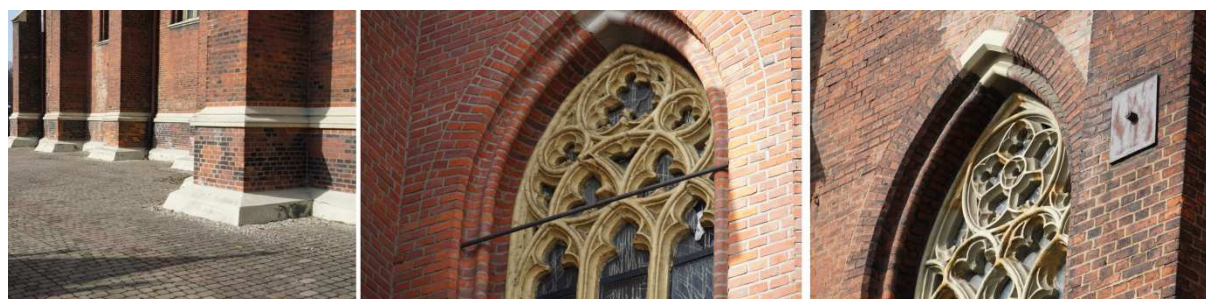
Fig.14 Some elements of outer reinforcement of the church construction; photo: Šcigata

the existing bar ties) were installed, too. The structure made this way, working in compression or tension, stiffens the level of the base of the vaults in case of longitudinal or transverse curvature of the land surface, both concave and convex. Figures 13 and 14 show some of those protection elements.

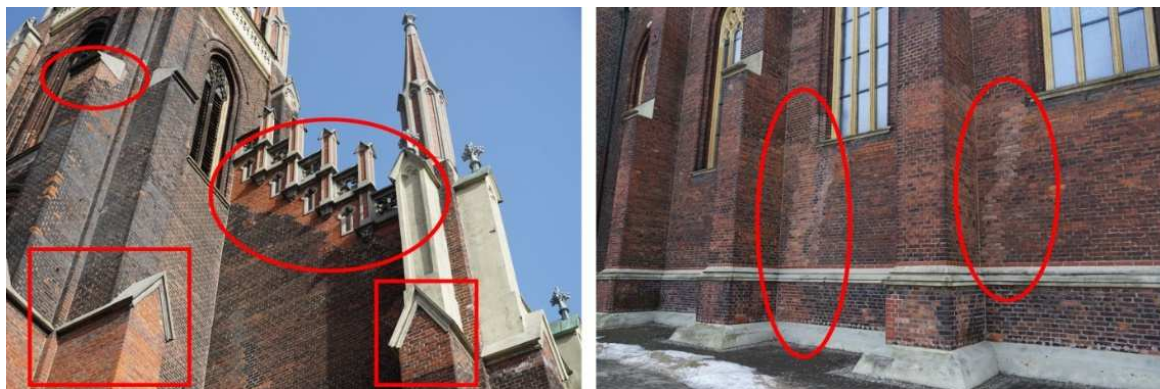
Fig.15 Some elements of the outer architecture of the church after reconstruction and renovation; photo: Šcigala

In recent years the object has undergone renovation, during which all damage to the structural and architectural elements that could endanger their stability was removed. All works were carried out under the supervision of the restorer of monuments, who ensured the restoration of the historical values of the building to the maximum extent. The current technical condition does not raise any objections. The photographs of selected reconstructed parts of the building are shown in Figure 15.
