Geotourism and water quality of river Hornád (E. Slovakia)

Janka Jablonská¹, Gejza Timčák and Lenka Pixová

The paper deals with some issues concerning geotourism and the environmental problems of the Hornád river valley (E. Slovakia). The data given below were obtained within the „RECENT“, „Caring after my river Hornád“ projects as well as from the Watershed management company (PBaH) databank. The paper gives some basic data on the river valley, and of the main contaminating agents. Then their significance from the point of view of environmental quality of the studied region and its impact on geotourism is analysed. The impact of water quality on trekking, water sports and fishing are considered, together with the aesthetic problems posed by waste dumping.

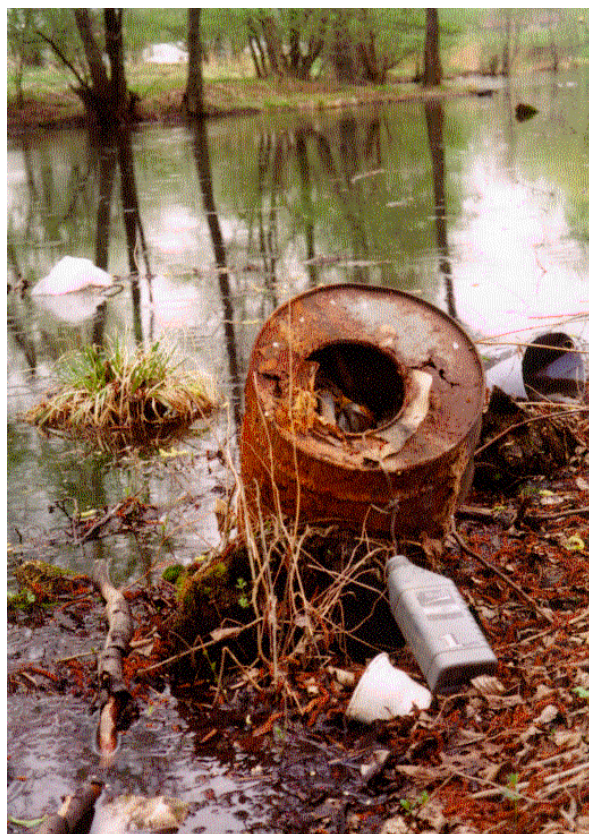
Fig. 2 A view of a part of an illegal dumping site at the outskirts of Košice - part nad Jazerom.

In geotourism, the state of the environment is always very important. The quality of environment depends on the synergy of geographical, geological and anthropic factors. Apart from geological and industrial reasons, one of the reasons for a relatively low quality of environment in the Hornád river valley is the low environmental awareness of the local inhabitants. Their way of managing communal and other waste (like scrape-metals, plastics, building material, chemicals, etc.) consists often of discarding them on illegal dumping sites that are frequently adjacent to the river. The situation is difficult also due to a lack of a reliable monitoring system that would help keeping track of the mobility of contaminants. A number of illegal dumping sites were mapped along the river. Fig. 1 shows their localisation. Fig. 2 shows a typical view of a part of an illegal dumping site near the river.

The geochemistry of river sediments reflects significant anomalies due to anthropic activity. Thus e.g. in the area of Myslava and Barca anomalies of Pb, Zn, Ag, and Cu were detected; at the sedimentation basin of the Košice Heat production plant (the cooling water is taken from Hornád) anomalies of As, Se, Li and Mo were detected; in the area of the confluence of Hornád and Torysa anomalies of Ag, Zn, Cu, Cd, Sn, Bi were found (Volko, 1995). The water quality of Hornád is affected also by the waste deposits along the river (Fig. 2).

Illegal dumping sites are in woods, on the riverside as well as in the water reservoir. The composition of material deposited at the described illegal dumping sites along the Hornád river is given in Tab. 6. Their character is illustrated by Figs 2, 5, 6. The most frequently occurring materials found at the dumps are plastics and plastic or metal boxes with remnants of their original contents. The remnants of contents can get mobilised and transported to soil and surface water.

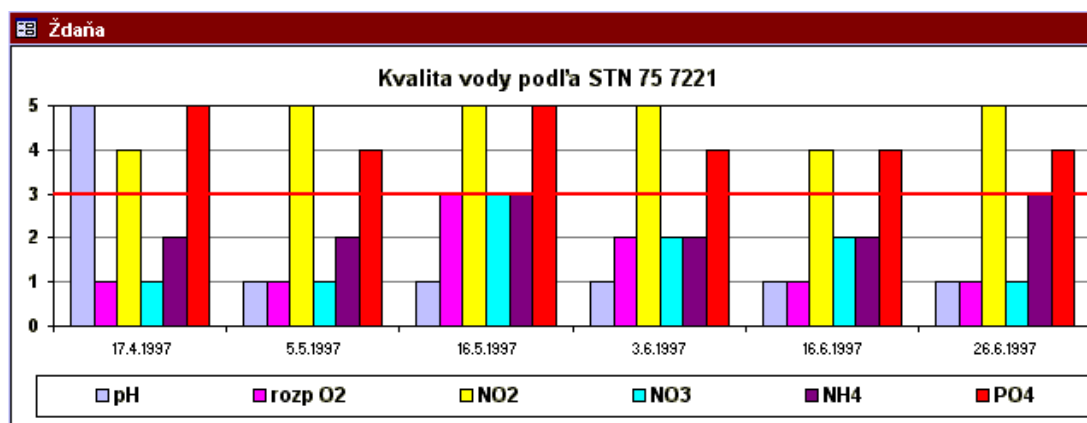
Fig. 4. Water quality by STN 75 7221 at Ždaňa (Southern part of the river) – by pH, soluble O₂, NO₂, NO₃, NH₄ and PO₄ content. Y axis: quality grade (5 – worst, 1 – best quality). X axis: sampling dates. Colours – data type. („Caring after my river Hornád“, 1997).

Within the „Caring after my river“ project of the SOSNA NGO, the pH, soluble O₂, NO₂, NO₃, NH₄ and PO₄ content was monitored in 1996-7 at 25 Slovakian and Hungarian localities. Figs. 3-4 show the 1997 results for the northernmost and southernmost point of the Slovakian part of the river that was monitored within the said project. Data on soluble O₂ and coliform bacteria contents in shown in Tab. 5a, 5b. It can be seen, how the surface water quality tends to vary and deteriorates along the river. The coliform bacterial content is higher then desirable. In Butkus (1999), the non-point source loading rates used for phosphorus and nitrogen species, biochemical oxygen demand, and total suspended solids in a model of Hornád river water quality improvement are shown (Tab. 4). The colour, taste and odour are affected by both organic and inorganic material. A spatial evaluation of all the factors was made by using GIS (Timčák, Orlitová, Dugáček, Jablonská, 1996).

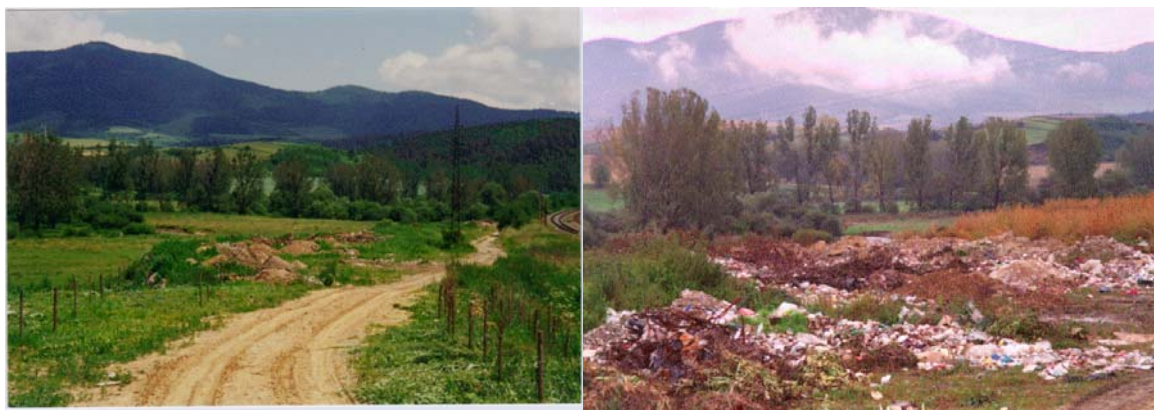
Fig. 5a, b. Dumping site in Sp. Vlachy, next to the railway station – near the field road. This dumping site was later simply covered by earth and re-vegetated.

Fig 5 shows the Spišské Vlachy illegal dumping site. It was later simply covered with earth (without remediation) and re-vegetated. The site will be thus forgotten and later only its adverse effect on the environment will be experienced, as the leaching of toxic material to the river (Fig. 6) will continue.
