Evaluation of Chemical Aging on Carousel Properties Due to the COVID-19 Anti-Pandemic Measures at Airports

chemical aging, light conveyor belt, Shore hardness, tensile properties, infrared spectroscopy

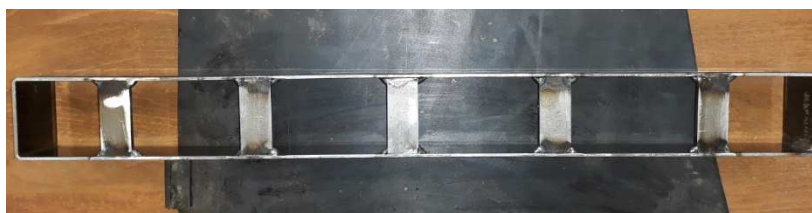
Samples were prepared from the conveyor carousel of the baggage handling system at Košice Airport. We prepared the test samples using a special cutting knife (Figure 1). The thickness of the test samples was greater than 4 mm for the purpose of determining the Shore hardness.

Fig. 1. Sample of a carousel with a cutting knife

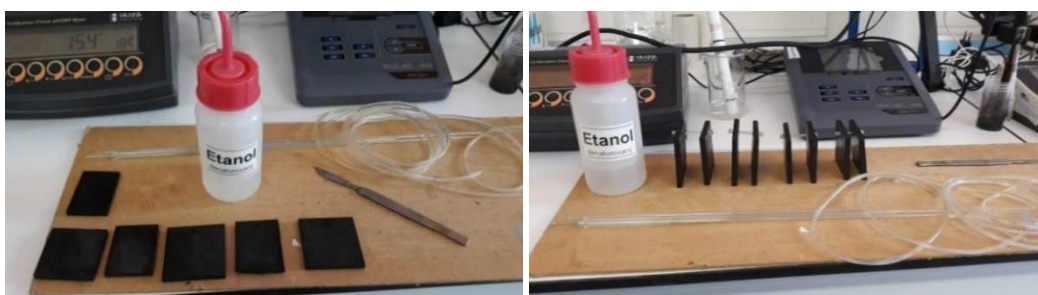
Preparation for Chemical Aging. ISO 1817 stipulates that a sample must be placed in a container 10 mm from the bottom and 5 mm from the walls of the container. For this purpose, the containers were assembled from glass tubes, rods, and cannula by the method of heat treatment. The samples were then cleaned with ethanol. Holes with a diameter of 4 mm were drilled in the upper part of the samples (Figure 2, on the left).

Fig. 2. Preparation of the sample pairs

A glass rod was threaded through the holes, which was secured with pieces of MASTERFLEX® capillary (Figure 2, on the right). Over the torch, hooks were made from glass rods to hang the samples in the containers (Figure 3, on the left). The rods were heated until they reached the consistency of honey, then shaped using a metal tool and gravity.

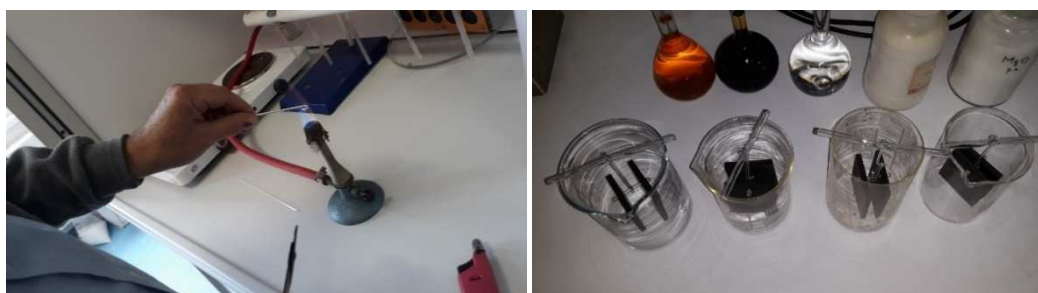
Fig. 3. Creation of hooks (left) and hanging of the samples in the containers (right)

The holders on which the samples were hung were similarly made from thicker glass tubes with the help of a torch (Figure 3, on the right). The prepared sample containers were then transferred to an evaporator and were labeled according to the disinfectant solutions: Sanytol, Savo, H₂O₂, and ethanol. After pouring in the solutions, the jars were sealed with paraffin foil (Figure 4).

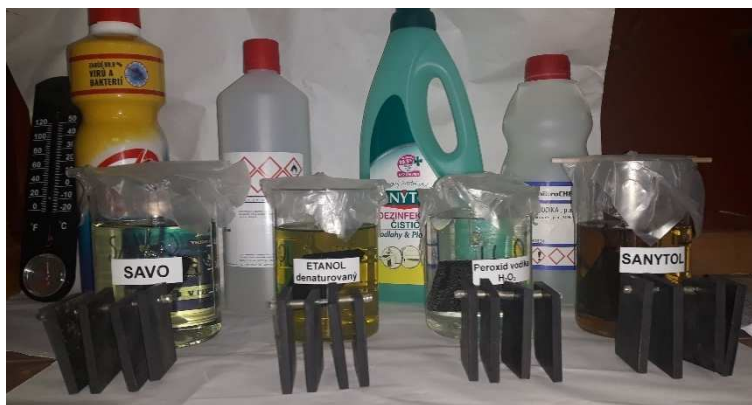
Fig. 4. Prepared samples placed in the containers; from the left: Savo, ethanol, H_2O_2 , and Sanytol

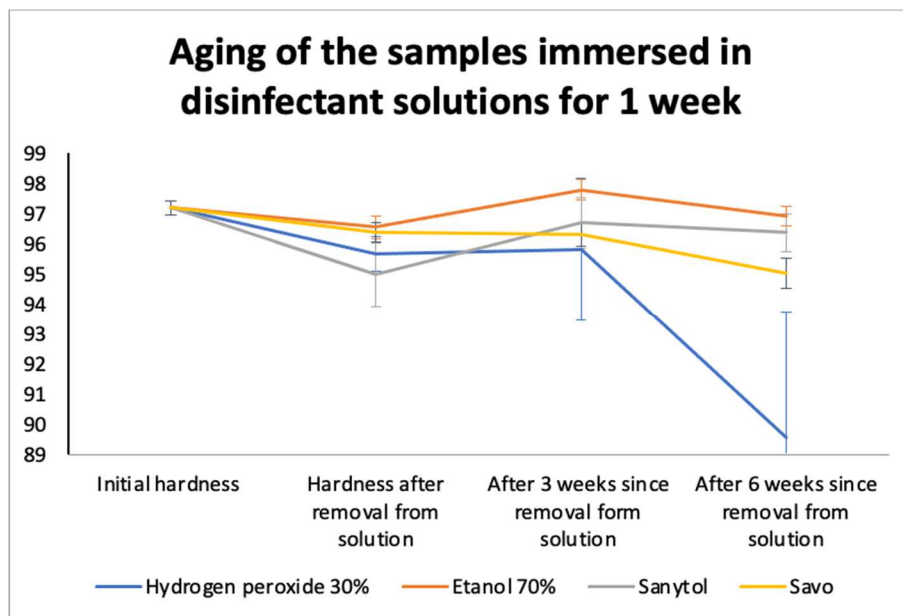
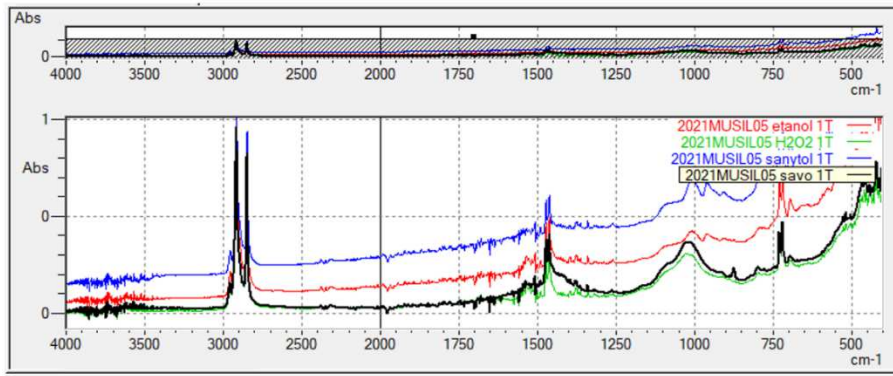
The experimental research was focused on an evaluation of changes in the mechanical properties, specifically the Shore hardness, of the carousel material. In the initial phase, we decided to determine whether there were relevant changes in the mechanical properties after 1 week of placement in the disinfectant solutions. As can be seen from Figure 5a, significant changes had taken place, and therefore the research continued in the subsequent phases. Changes in composition induce different shapes of absorption bands in the range $1100-800$ cm^{-1} (Figure 5b).

Fig. 5. (a) Aging of the samples immersed in disinfectant solutions for 1 week; (b) IR spectra of samples immersed for 1 week

The effect of the disinfectant solutions changed the hardness, which mostly decreased (Figure 5a). After checking the samples taken after 1 week from the disinfectant solution (after 3 weeks of natural aging) for ethanol and Sanytol, the hardness increased to a higher value. However, after 6 weeks, the hardness began to decrease. We did not expect to find that a decrease in hardness occurred during aging, and a significant decrease in the case of H_2O_2 was all the more surprising.

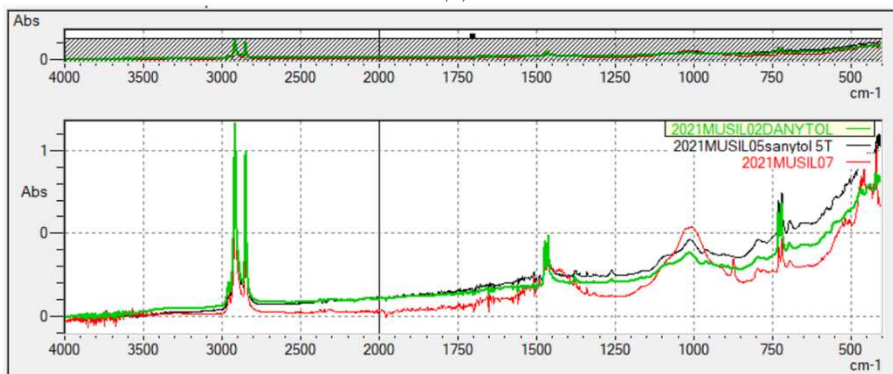
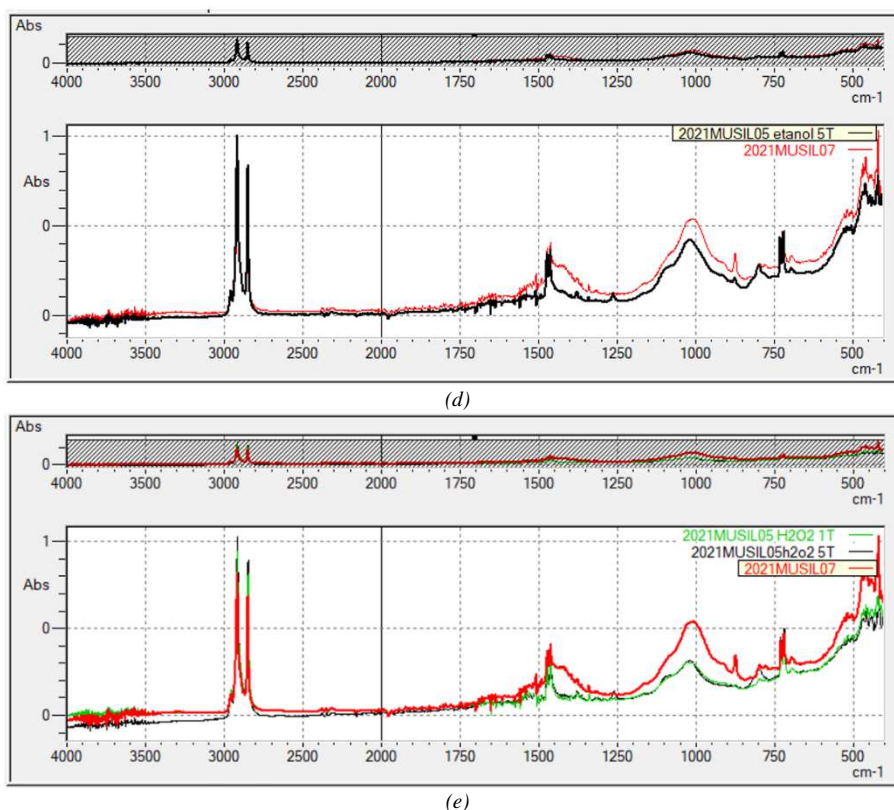
Fig. 10. (a) Hardness development for individual weeks in the disinfectant solutions; (b) IR spectra of samples immersed in Savo; (c) IR spectra of samples immersed in Sanytol; (d) IR spectra of samples immersed in ethanol; (e) IR spectra of samples immersed in hydrogen peroxide

The results of the research on the changes in hardness can be summarised as follows (Figure 10a): contrary to the original hypothesis, the samples gradually softened due to the solutions that were used. In Week 3, the opposite trend began to appear in the case of H_2O_2 and Savo; however, these samples began to soften again at 4 weeks. Sanytol caused the maximum hardness change, while ethanol caused the minimum change – this occurred during the 5th week. Overall, there was a clear trend of decreasing hardness during the disinfection, but during aging, changes in the hardness occurred, which were characteristic of the particular solutions.

During the action of Savo, changes in composition induce different shapes of absorption bands in the area of deformation vibrations, especially in the range of $1100-800\text{ cm}^{-1}$ (Figure 10b). As in the case of Savo, changes in composition for the action of Sanytol induce different shapes of the absorption bands in the region of deformation vibrations, especially in the range $1100-800\text{ cm}^{-1}$ (Figure 10c). The treatment of ethanol (Figure 10d) in 1st and 3rd week shows a negligible difference compared to the reference sample; the result is the same spectrum, with a small change only after 5 weeks. Under the action of hydrogen peroxide (Figure 10e), the deductive effect starts immediately after 1 week and does not change within 5 weeks. The changes are similar in nature to Sanytol and Savo.

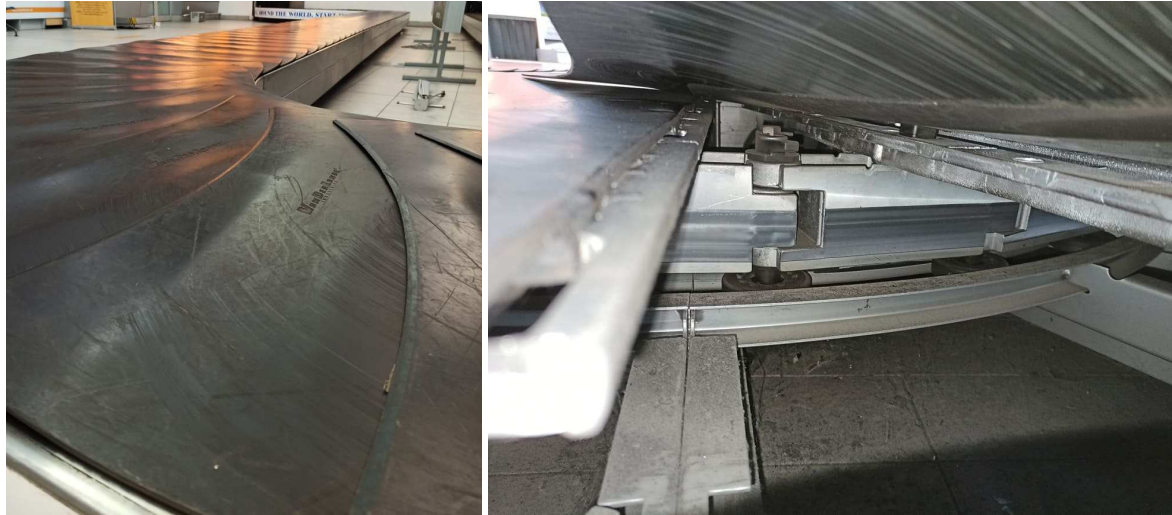
Disinfectant solutions, like any liquid, drain into the gaps of materials, for example, the areas where pieces of the carousel fit together (Figure 11). There, they actually act as if they were in a closed container, which can lead to considerable degradation. These are also the places that undergo the maximum damage. The standard deviations are related to uneven degradation due to different degrees of operational damage. A disinfectant solution that has penetrated into the cracks and splits could act inside the sample even after its removal from the solution.

Fig. 11. Baggage belt conveyor in the airport and (on the right) detail of the conveyor under the belt

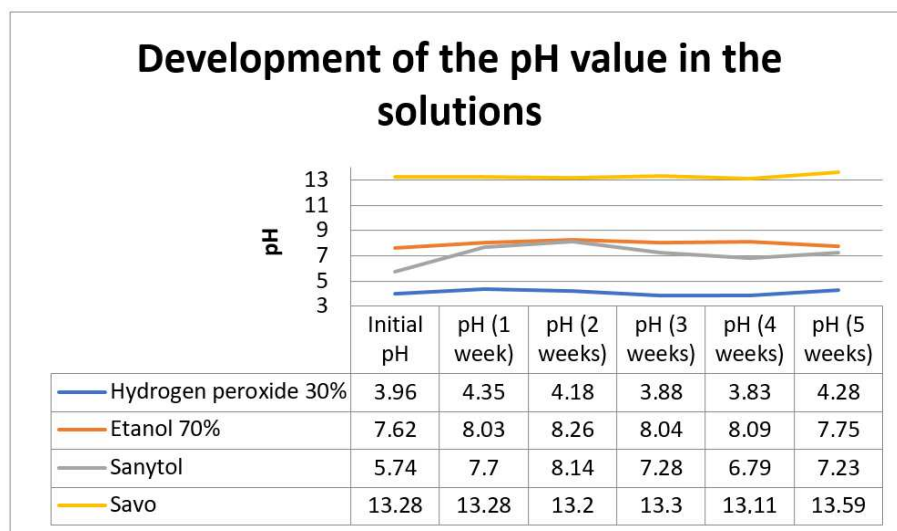
The hypothesis that the hardness does not depend on the pH value can be considered to have been confirmed (Figure 12). For example, even the max. (Savo) and min. (H_2O_2) pH values did not affect the hardness at all – this was confirmed by almost identical hardness profiles after the 3rd and 4th weeks.

Fig. 12. Development of the pH value in the solutions

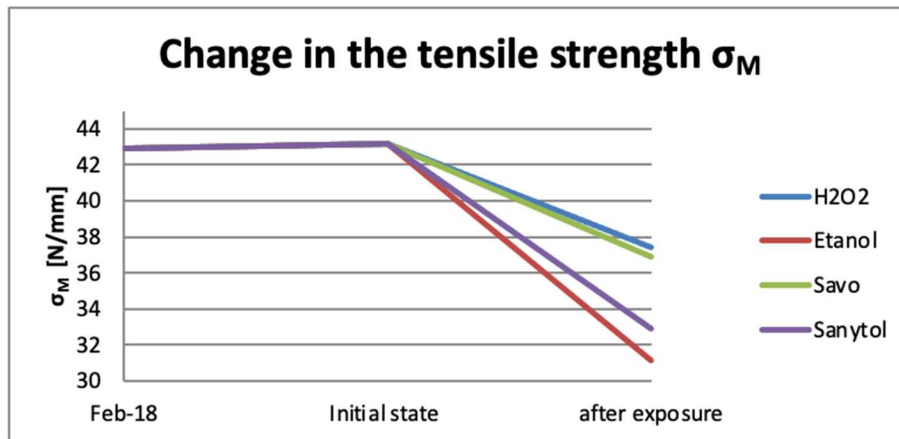
The value of the deformations ε_B changed considerably due to the action of the disinfectants. The tensile strength σ_M decreased in all the bodies immersed in disinfectant solutions for 5 weeks, which corresponded to a decrease in hardness (Figure 16).

Fig. 16. Change in the tensile strength σ_M

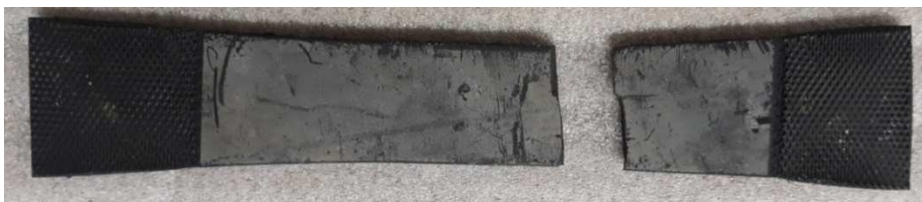
Fig. 18. Degraded, torn sample
