Observations of the oil-polluted soil of Absheron Peninsula using Landsat 8 OLI and Sentinel 2A imagery

Saddam HASHIMOV¹ and Jarosław ZAWADZKI^{2*}

Hashimov, S. and Zawadzki, J. (2022) Observations of the oil-polluted soil of Absheron Peninsula using Landsat 8 OLI and Sentinel 2A imagery. *Acta Montanistica Slovaca*, Volume 27 (3), 607-619.

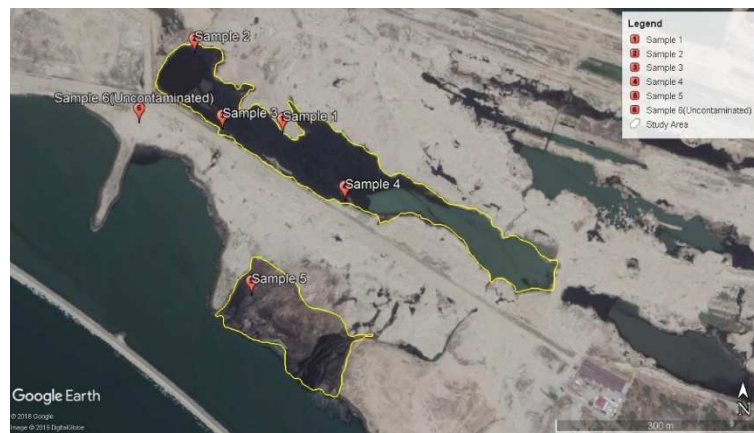
Fig. 2. The specific study area is composed of two contaminated areas Northern and Southern, close to each other. They are delineated using yellow lines and denoted furthermore as to Area #1 and Area #2. The points where samples were taken from the research area are also shown. Coordinates of the areas are : #1) 40°26'40.6"N 49°54'34.3"E , #2) 40°26'34.3"N 49°54'30.3"E

More specifically, the study area is situated in the north coastal area of Boyukshor Lake (Fig.2). Boyukshor Lake is located 4 m above sea level, in the middle of the Absheron Peninsula. The surface area of the lake is 1300 ha, and the volume of water is 47.3 million m³. All wastewater near factories and residential areas is discharged to Boyukshor Lake. Water samples taken from the lake show that the lake water is polluted and mineralized more than the norm (120g/l) (Hacke et al., 2012). Lack of oxygen has been observed in the lake water; it is caused by the oxidation process of pollutants thrown in the lake. The concentrations of phenol and petroleum products are 20 and 66 times more than the norm (Hacke et al., 2012). Although some actions have been taken, part of Boyukshor Lake is drained for treatment (Kuric et al., 2020). The pollution level is still very high, and the contamination process is still ongoing (Muravev et al., 2019). The study area was divided into 2 zones, northern and southern, close to each other and denoted furthermore as Area #1 and Area #2, respectively (Fig. 2, yellow contours). The surface of the first area is approx. 40.5 hm² and the second area is approx. 26 hm².

Six samples were collected from polluted and non-polluted areas to analyze the physicochemical properties of the soil (Fig.2).

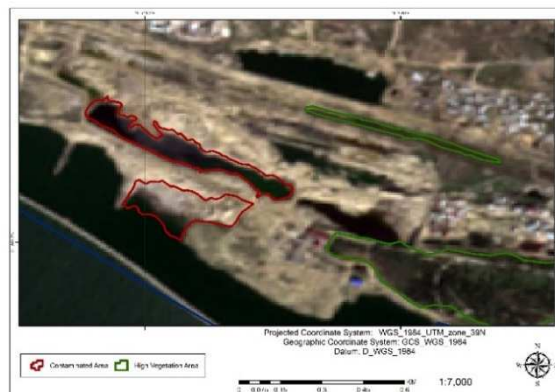
Fig. 6. Sentinel 2A, True Color Imagery of the study area. The True Color Image is obtained from Sentinel 2A in the winter with 10 m spatial resolution. Date: 31.01.2018

Figs 5 and 6 represent True Color images of the contaminated area which have been taken by Landsat 8 OLI and Sentinel 2A during the winter season, while Figs 7 and 8 demonstrate True Color images of Landsat 8 OLI and Sentinel 2A in summer. The red and green outlines in the given imagery are contamination and vegetation areas, respectively. In contrast to the situation shown in Figs 5 and 7, it is possible to see the clearly contaminated and vegetation areas in Figures 6 and 8, obtained from 10 m spatial resolution imagery of Landsat 8 OLI.

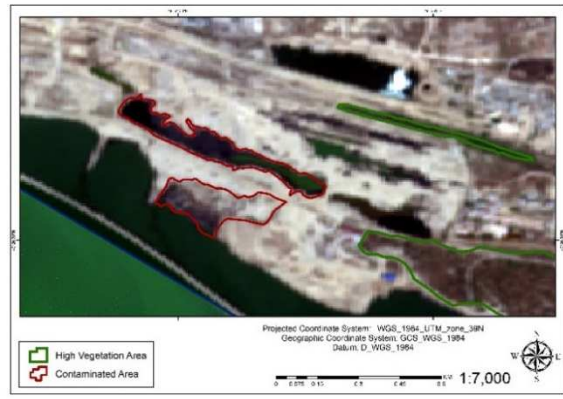
Fig. 8. Sentinel 2, True Color Imagery of the study area. The True Color Image is obtained from Sentinel 2A in the summer season with 10 m spatial resolution. Date: 10.07.2018

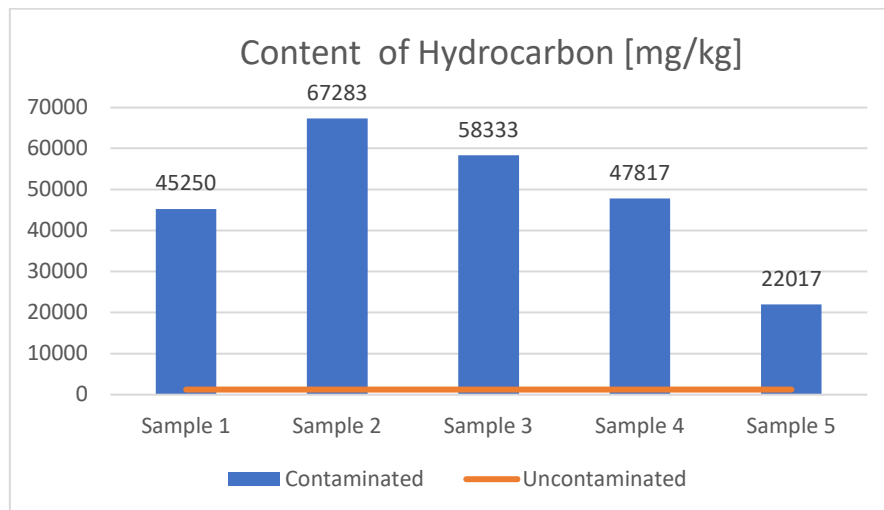
Fig.13. Graph of the content of hydrocarbon mg/kg in studied soil samples

For validation purposes, the content of hydrocarbon in the collected soil samples was determined in the laboratory. Fig. 13 presents the histogram of the content of hydrocarbon in mg per kilogram in the studied contaminated samples in the summer season. The blue bars demonstrate the hydrocarbon content in the samples taken from contaminated area while the orange line in the sample is taken from a relatively clean place. In the latter sample, the content of hydrocarbon was 1267 mg/kg. The highest contamination value has been observed in Sample 2, namely 67283 mg/kg (Figs 13, 14). Thus, the pollution of the site considered to be clean was only about 2% of that of the most polluted site.

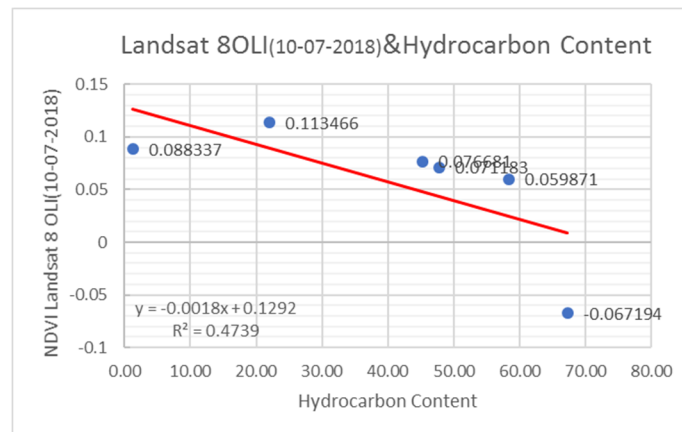
Fig.15. Scatter plot and regression line between NDVI obtained from Landsat 8 OLI satellite in the summer season [Landsat 8OLI (10-07-2018)] and hydrocarbon content in the soil samples

In order to determine the statistical relationship between NDVI calculated based on Landsat 8 OLI and Sentinel 2A satellite imagery and hydrocarbon content in soil Pearson's correlation coefficient has been calculated using NDVI and validation measurements. Fig.15 shows an exemplary relationship between these variables on July 7, 2018.

As shown in Fig.15, the clear dependence between NDVI and the hydrocarbon content in the soil samples exists. Pearson's correlation coefficient based on this regression line is relatively high in absolute value and negative (- 0.69). This indicates that when NDVI values decrease, the amount of hydrocarbon content increases.
