Influence of Vibration and Ground Deformation on Historic Structures: Case Study

Zdeněk KALÁB^{1,2*}, Roman ŚCIGAŁA³ and Piotr STRZAŁKOWSKI⁴

Abstract

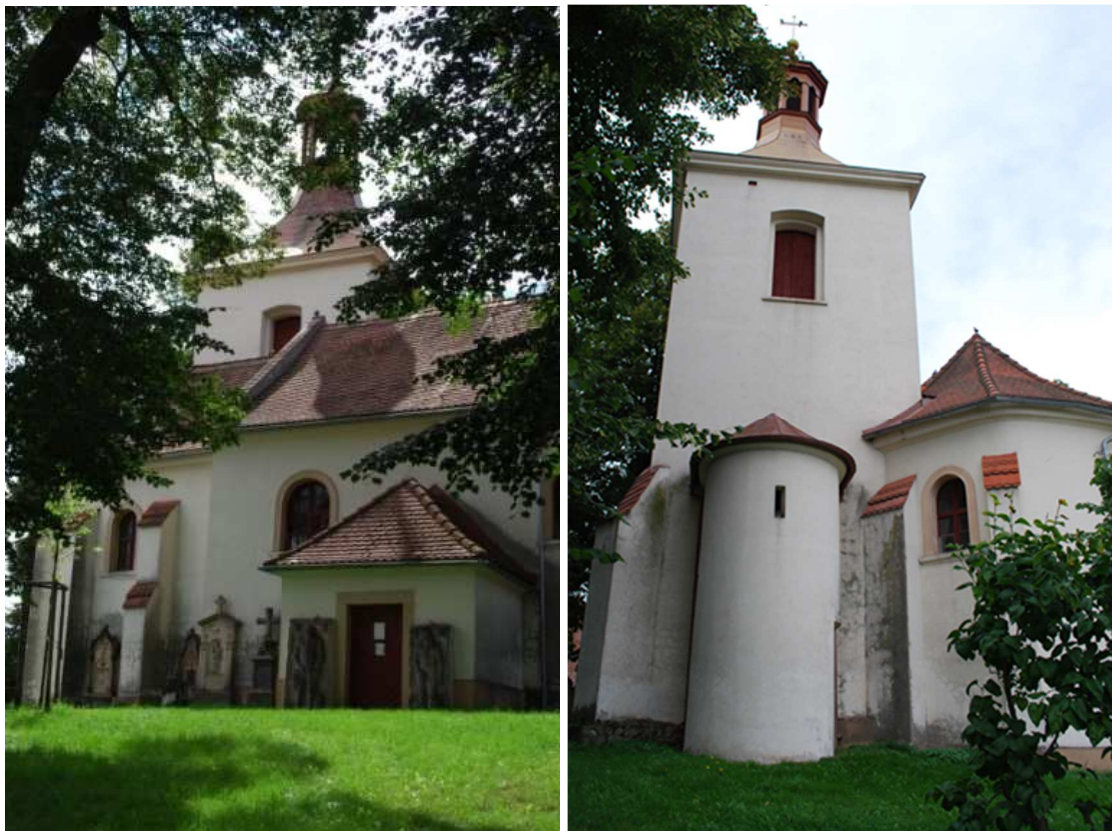
The church dedicated to St. Andrew in the village of Světí (near Hradec Králové, Czech Republic) is first mentioned in archival sources as early as 1365 (Fig. 2A). The church has preserved its late Gothic layout to this day, although it was remodelled in the Renaissance style at the end of the 16th century and later in the slightly Baroque. The last significant building modifications took place in the second half of the 19th century (more Kostel svatého Ondřeje ve Světí, 2021/). The area of the church is about 20 * 10 m, and the tower's height is about 23 m (personal communication). The church is registered in the List of Immovable Cultural Monuments of the Czech Republic. However, the walls and the ceiling have considerably fractured. The typical examples of failures generated by traffic are presented in Fig. 2B.

Experimental measurements have shown that the primary cause of damage to the church in Světí is the foundation of the building in a sloping area. The vibrations generated by traffic on nearby roads do not reach values that would directly cause damage to the building. Thanks to the historical value of the building, we can reduce the values of maximum permissible vibrations. It can be reasonably assumed that the vibrations significantly worsen the technical condition of the building.

Fig. 2A Church dedicated to St. Andrew in the village of Světí (near Hradec Králové, Czech Republic); photo: Kaláb

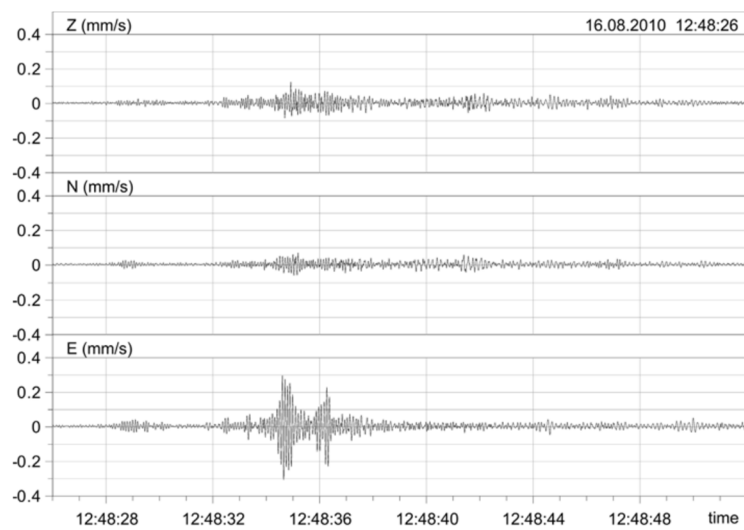
The example of a wave pattern was obtained from the seismometer that was located inside the church near the wall with the most significant failures (Fig. 4 and Fig. 5). This vibration was caused by a passing truck. Generally, the maximum component value of velocity (horizontal component towards the road) during an experimental measurement was 0.44 mm.s⁻¹, important harmonic vibration about 8 – 12 Hz, and the duration of seismic effects was approximately 7 s (Kaláb et al., 2012).

Fig. 4 Wave pattern of vibration induced by road traffic (the sensor signed as SVE was located inside the church)

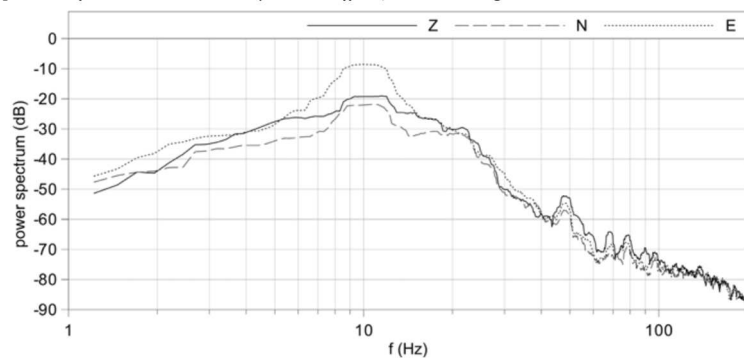
Fig. 5 Frequency spectrum of vibration induced by road traffic (the sensor was located inside the church)

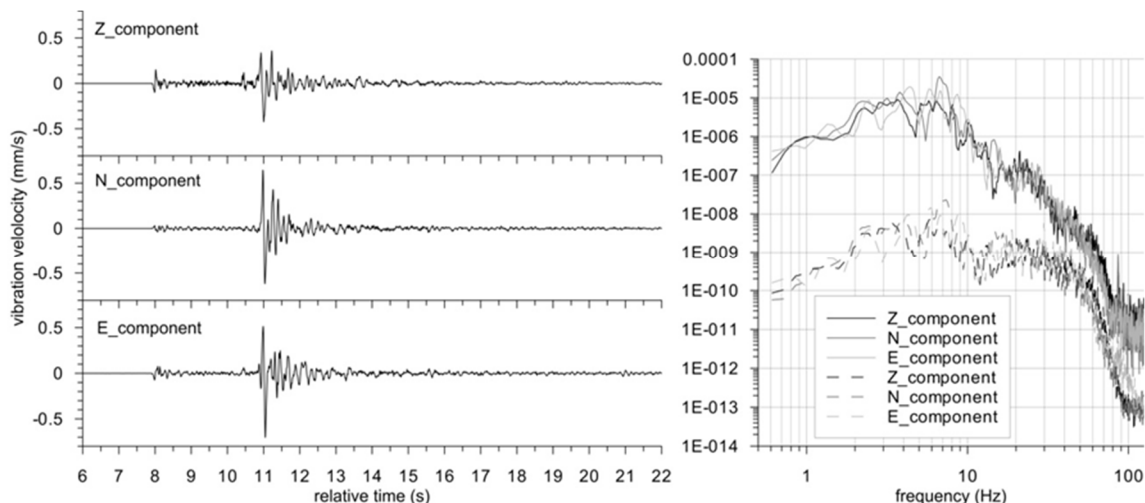
Since 2010, five natural swarms have happened: in 2011, 2014, 2017, 2018, and 2020 (not finished until the end of the year). The strongest earthquake occurred during the swarm in 2014, with a local magnitude of 4.4 (doi:10.7914/SN/WB). To document the seismic loading of the mine due to natural seismicity, the following number of earthquakes were recorded from the mentioned area: in 2017 – 202 earthquakes; in 2018 – 124; and in 2019 – only 27 earthquakes. The example of the wave pattern recorded by the seismic station JER1 placed in the mine and the spectra are presented in Fig. 7.

Fig. 7 Wave pattern and spectra of the earthquake from the West Bohemia focal zone recorded at the seismic station JER1; left – wave pattern of ML 3.6 earthquake occurred on 4 August 2014; right – spectra of ML 3.6 earthquake (solid line) and spectra of ML 2.1 earthquake (dashed line)

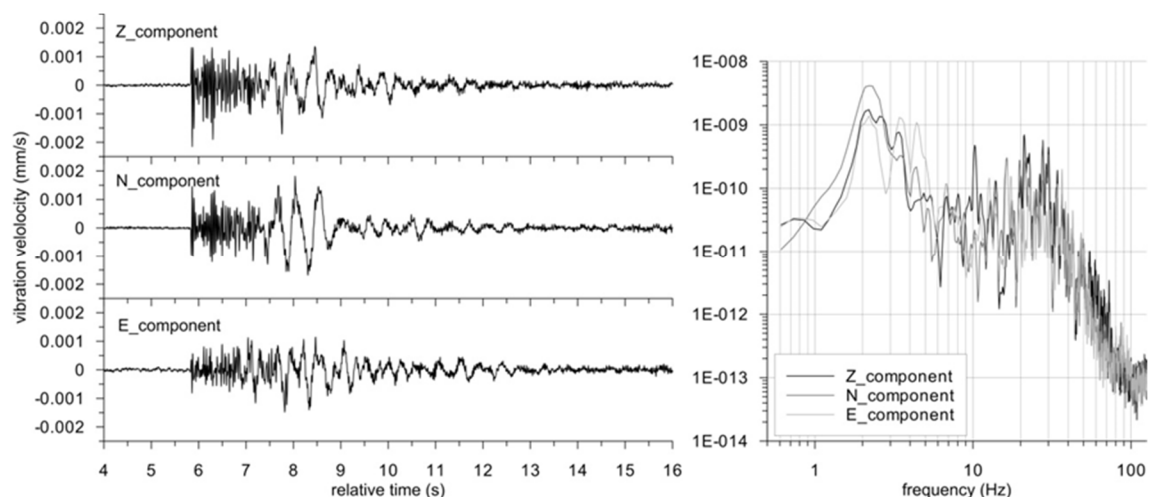
Although earthquakes cause the maximum vibration effect, technical seismicity also causes not negligible vibration effect in underground spaces (as mentioned above). Detailed analysis of the vibration effect caused by individual seismic sources is performed in the time and frequency domain. The example of the wave pattern and spectra of a quarry blast recorded at the seismic station JER1 are presented in Fig. 8. The fall of a rock block from the ceiling is a long-term process that is the consequence of deformation, weathering, and seismic loading. Currently, these situations were described first of all in the inaccessible part of the mining work but not only (Kaláb, Loskot, 2020).

Fig. 8 Wave pattern and spectra of a quarry blast at Vítkov recorded at the seismic station JER1
